Your Personal Home Inspection

123 Somewhere Street
Yourtown, US 12345

Prepared for: Bob Client

Prepared by: Downriver Home Inspections
1234 Company Lane
Somewhere, US 12345

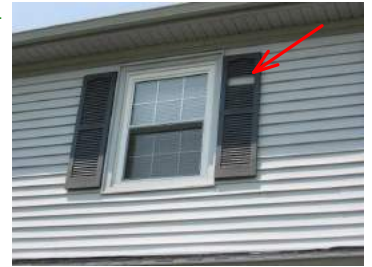
2. Type: Vinyl siding Damaged front shutter, Chalking noted due to age, One panel needs to be repositioned at rear elevation

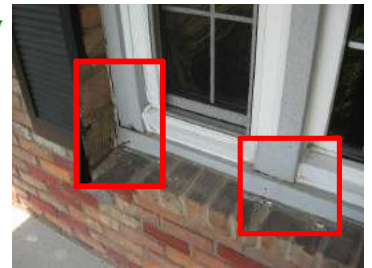
3. Trim: Aluminum Chalking noted due to age, Loose nails in areas
4. Fascia: Aluminum
5. Soffits: Vinyl Loose/sagging at front porch
6. Door Bell: Hard wired
7. Entry Doors: Wood
8. Patio Door: Vinyl sliding Resecure loose handle hardware, Screen damage noted
9. Windows: Vinyl insulated Reseal caulking at window perimeters at brick window openings

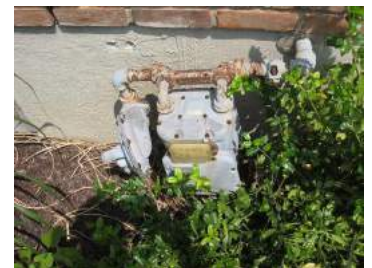
10. Window Screens: Metal
11. Basement Windows: Vinyl casement
12. Exterior Lighting: Surface mount
13. Exterior Electric Outlets: 110 VAC GFCI
14. Hose Bibs: Gate Properly secure fixture(s) to exterior wall with fasteners
15. Gas Meter: Exterior surface mount at side of home Rust present, Keep bushes and shrubs away from meter

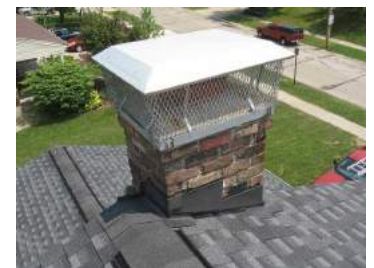
Right side Chimney

- 12. Chimney: Brick
- 13. Flue/Flue Cap: Clay tile Weather cap obstructed view of flue

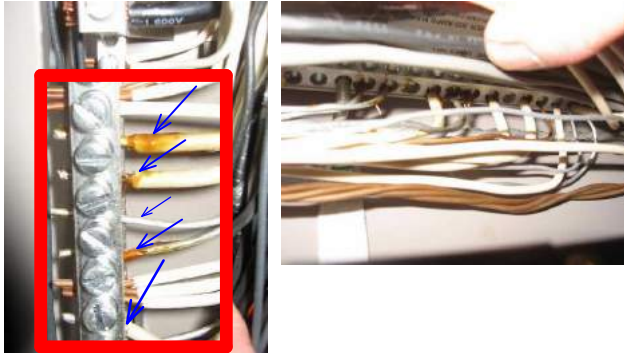
1. Service Size Amps: 200 Volts: 120/240 VAC
2. Service: Aluminum
3. 120 VAC Branch Circuits: Copper and aluminum *Evaluation by a licensed electrician is recommended, See aluminum wiring notes below*

4. 240 VAC Branch Circuits: Copper
5. Aluminum Wiring: Present at several circuits *Aluminum branch wiring has had a history of problems relating to poor connections due to galvanic corrosion, dissimilar metals, brittle conductors and type of aluminum alloy used during the time period of 1965 through 1972. These problems create unsatisfactory conditions at connections and splice locations and therefore create potential fire hazards. Recommend wiring update for aluminum wiring by a licensed electrician, Circuits are recommended to be upgraded with special compression type connectors at splices and branch circuits to reduce the potential risks of aluminum branch wiring. (Cop-Alum Crimp System)*

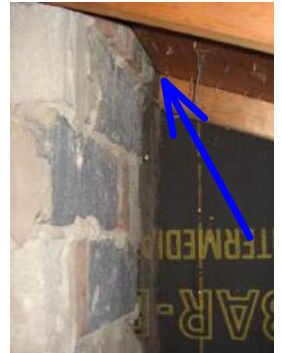
1. Method of Inspection: In the attic
2. Unable to Inspect: 15% Safety and footing
3. Roof Framing: 2x3/4 Truss Wood blocking components missing at chimney perimeter

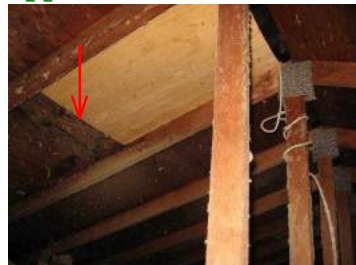
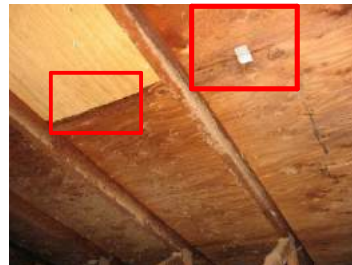
9. Method of Inspection: In the attic
10. Unable to Inspect: 10% Safety and footing
11. Roof Framing: 2x3/4 Truss
12. Sheathing: Plywood Poor repair at 2 areas near ridge at rear slope - No H clips installed and repair only spanned one truss - Recommend additional support be installed

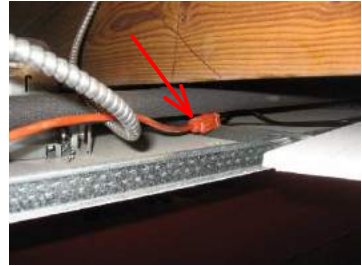
- 2. Ceiling: Suspended Acoustical System Evidence of past water staining
- 3. Walls: Drywall
- 4. Floor: Carpet **Carpet stains noted**
- 5. Floor Drain: Surface drain
- 6. Doors: Hollow wood
- 7. Windows: Vinyl casement
- 8. Electrical: 110 VAC **Loose junction boxes, missing and mis-sized covers, extension cord wiring to projector**

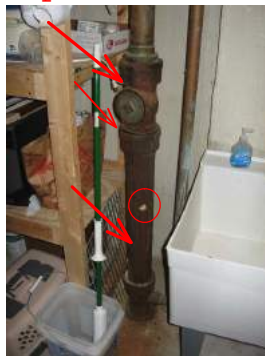
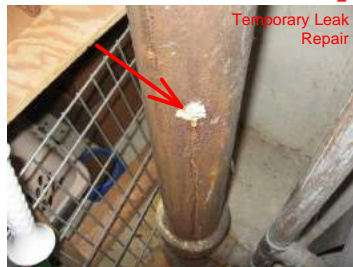
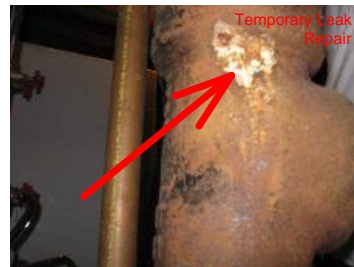
- 1. Service Line: Copper
- 2. Main Water Shutoff: Basement
- 3. Water Lines: Copper
- 4. Drain Pipes: Cast iron, Copper **Pitting cast iron drain piping stack - replace affected sections where required**

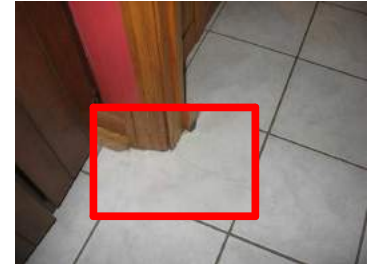
28. Ceiling: Drywall
29. Walls: Drywall
30. Floor: Ceramic tile **Cracked tile noted**

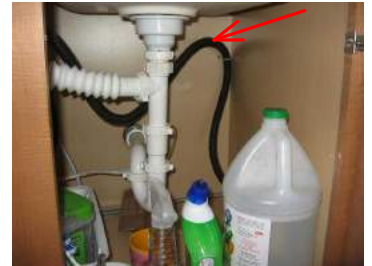
- 1. Cooking Appliances: Frigidaire
- 2. Disposal: General Electric
- 3. Dishwasher: Maytag **Properly secure the dishwasher discharge hose so that it creates a "high loop" above the basin drain to minimize food or water backup under dishwasher**

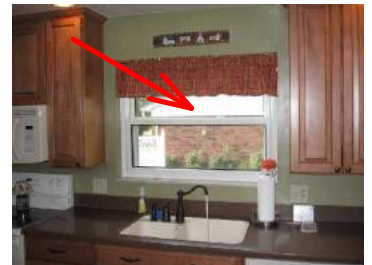
- 4. Air Gap Present? Yes No
- 5. Refrigerator: Amana
- 6. Microwave: General Electric
- 7. Sink: Stainless Steel **Chipping at drain**
- 8. Electrical: 110 VAC GFCI
- 9. Plumbing/Fixtures: Stainless Steel
- 10. Counter Tops: Solid Surface
- 11. Cabinets: Wood Loose cabinet door hinges
- 12. Pantry: Large
- 13. Ceiling: Drywall
- 14. Walls: Drywall
- 15. Floor: Ceramic tile
- 16. Doors: Hollow wood
- 17. Windows: Vinyl Insulated **Insulated glass unit seal failure**

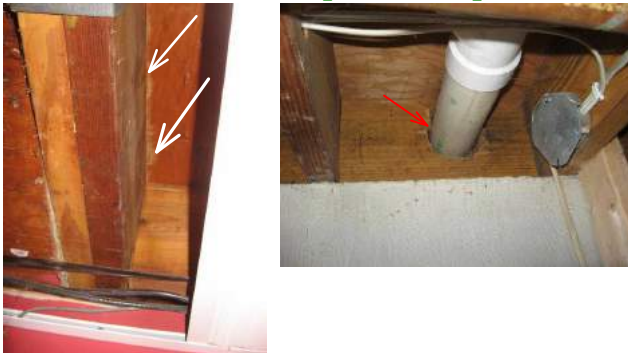
19. Joists/Trusses: 2x10 Areas not visible due to ceiling finishes or other obstructions, Framing joist near fireplace chimney shows evidence of previous termite infestation - No repairs required, Seal penetration as required

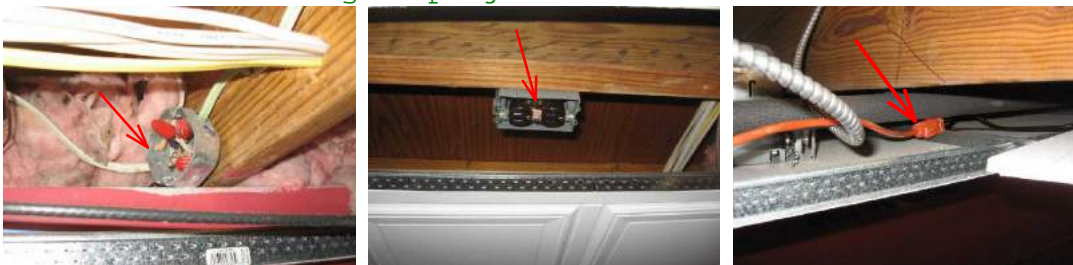
20. Main Basement Floor: Carpet Carpet stains noted
21. Main Basement Electrical: 110 VAC Loose junction boxes, missing and mis-sized covers, extension cord wiring to projector

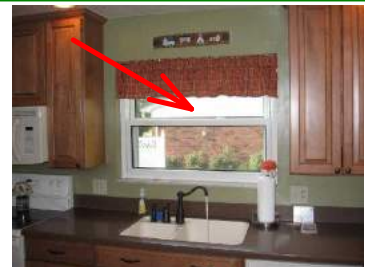
6. 1st Floor Kitchen Windows: Vinyl Insulated Insulated glass unit seal failure
