Your Company Name Here
9600 Colerain Ave., Suite 110
Cincinnati, OH 45251
OH License #12345

Home Inspection Report

1234 School House Road
Yourtown, US 12345

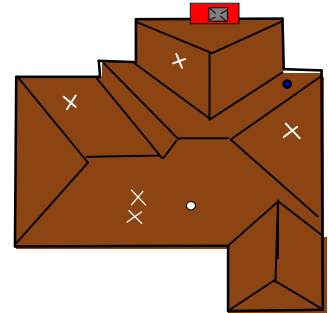
1. Method of Inspection: On roof
2. Roof Diagram

4. Material: Fiberglass shingle Nail popping through shingle surface in various locations causing potential water intrusion (see diagram above marked "x")

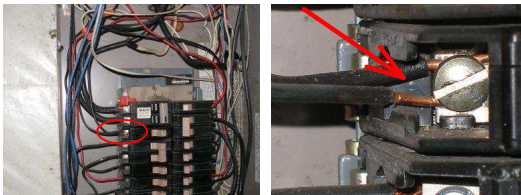
Basement Electric Panel

9. Manufacturer: Cutler-Hammer
10. Maximum Capacity: 100 Amps
11. Main Breaker Size: 100 Amps
12. Breakers: Copper Double taps are present at breakers. These circuits need to be moved to their own circuit breaker and cannot share a breaker. It is recommended that a qualified electrician inspect the new circuits and properly connect the new circuits to an individual breaker for each circuit

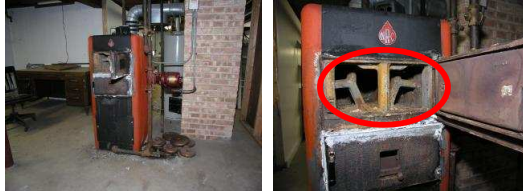
Basement Heating System

1. Heating System Operation: Recommend replacement Boiler system is antiquated and lacks safety features found on newer units including non-sealing combustion chamber which can cause health issues
2. Manufacturer: NRC
3. Model Number: Not Listed Serial Number: Not Listed
4. Type: Boiler system Capacity: Not Listed
5. Area Served: Whole building Approximate Age: 70
6. Fuel Type: Natural gas
7. Unable to Inspect: 0%
8. Distribution: Hot water, One pipe
9. Circulator: Pump
10. Draft Control: Manual
11. Flue Pipe: Single Wall Metal
12. Controls: Relief valve
13. Thermostats: Single Zone
14. Suspected Asbestos: No
