Your Company Name Here
9600 Colerain Ave., Suite 110
Cincinnati, OH 45251
OH License #12345

Home Inspection Report

1234 School House Road
Yourtown, US 12345

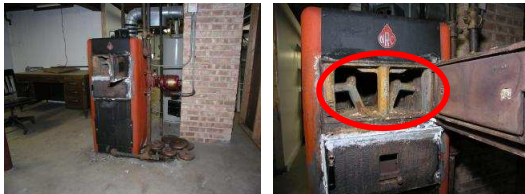
14. Basement Heating System Heating System Operation: Recommend replacement Boiler system is antiquated and lacks safety features found on newer units including non-sealing combustion chamber which can cause health issues

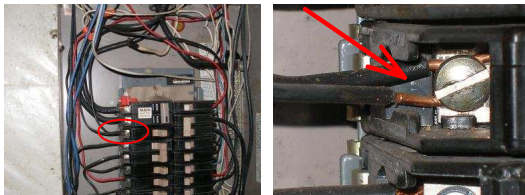
10. Basement Electric Panel Breakers: Copper **Double taps are present at breakers. These circuits need to be moved to their own circuit breaker and cannot share a breaker. It is recommended that a qualified electrician inspect the new circuits and properly connect the new circuits to an individual breaker for each circuit**
